Eric BIRD, Ena MARTIN, Kaarel ORVIKU

REED ENCROACHMENT ON ESTONIAN BEACHES

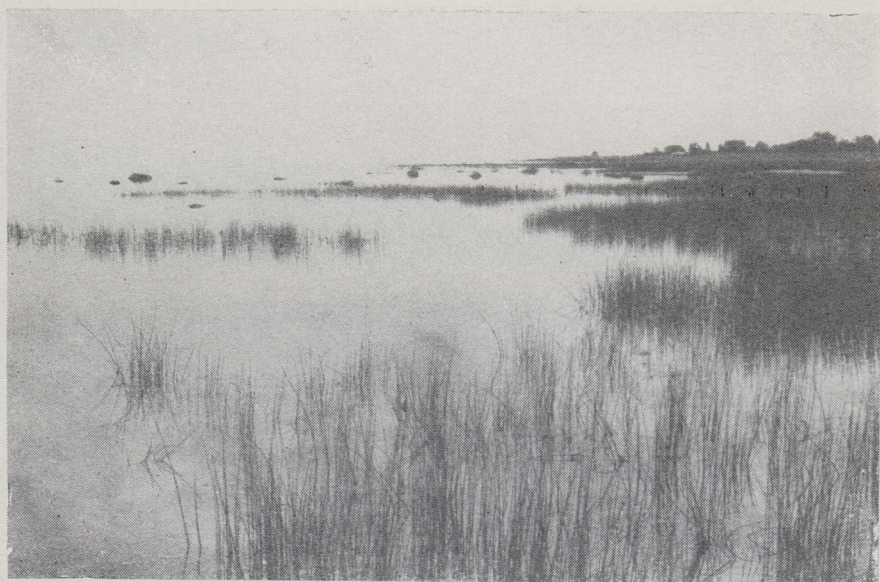
Fig. 2. Reed spread in the eastern part of the Pärnu beach under the effect of waste waters inflow.

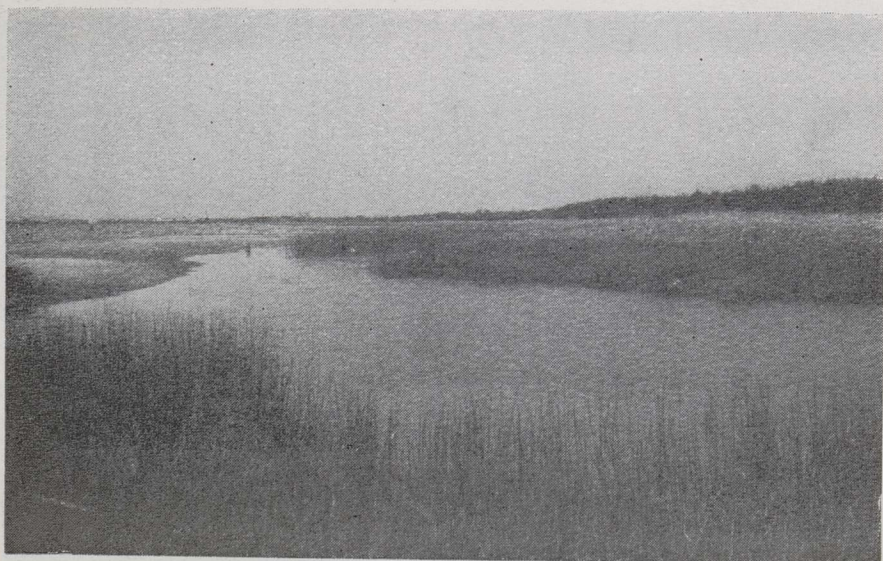
Fig. 3. Beach vegetation has entirely occupied the low southwest coast of Pärnu Bay.

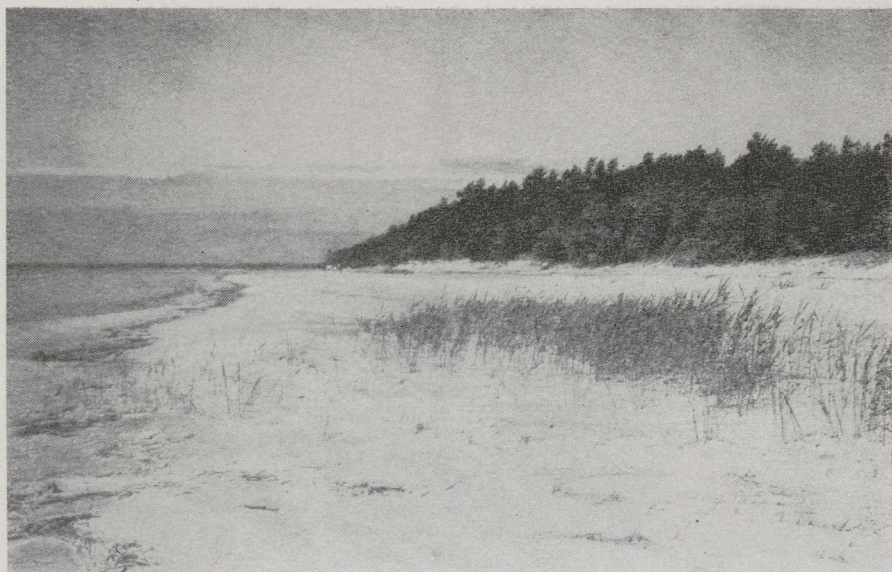
Fig. 4. The encroachment of beach vegetation has started also in the eastern part of the Valgeranna prograding beach.

Substrate conditions have changed where beaches have been cut back and lowered by erosion, and this is certainly a major factor in the observed reed encroachment in Estonia. On the beach at Valgeranna, for example, there is a contrast between the eastern section, which is prograding, and has low dunes developing behind a beach that is broad, high and slightly convex in profile (Fig. 4), and the western section, where the dune margin has been cliffed and the beach profile is lower and flatter (Figs 5 and 6). As the fine sand is lowered, it becomes damp, intersecting the water table, and it also acquires silt and clay particles. Such conditions permit the spread of phragmites and associated rushes along the shore. The Pärnu beach consists also of fine sand, and it is often overwashed by waves where it forms a low, gently convex barrier in front of the reedswamp zone east of the town. If the beach were higher

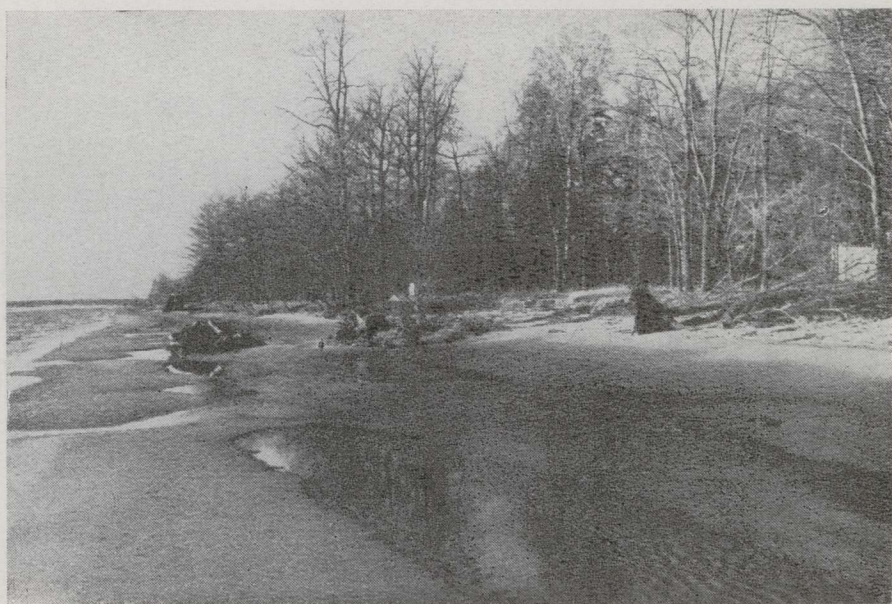
Fig. 5. In the western part of the Valgeranna resort storm damages have intensified in last decades.

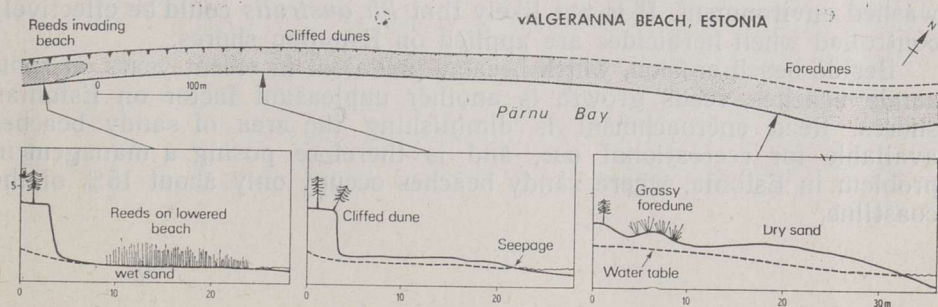
Fig. 6. Reed encroachment on the Valgeranna Beach, Pärnu Bay, Estonia. *Phragmites* is invading the western end of the beach, which has been cut back and lowered by erosion in recent decades. Sand has drifted north-eastwards to a prograding sector of the beach, which is wider and higher, and backed by grassy foredunes.

and wider it would form the more permanent barriers, but the repeated overwashing has reduced it to a level on which *Ph. australis* can advance seawards.
